# Manhole Inspection Summary

Manhole # S25E1\_003MH

Insp Date: **4/17/08 12:33 PM**

**Location** Address: **2425 ANNAPOLIS RD.**

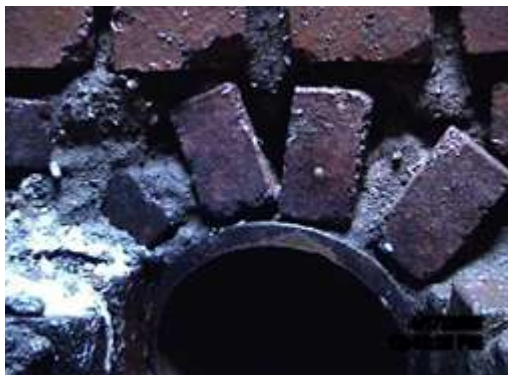
Defect 1

Condition: ☐ Sound ☐ Cracked ☐ Root Intrusion ☒ **Loose Brick** ☐ Deteriorated

LOOSE BRICKS AROUND THE 9 O  
CLOCK

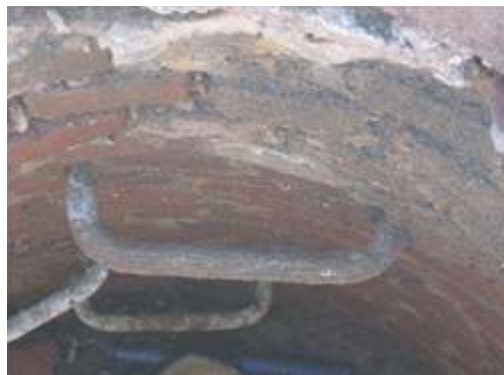
Defect 3

Infiltration: ☐ None ☐ Joint ☐ Cracks ☐ Mortar ☐ Roots ☒ **Wall**

Count: **3** Missing: **0** ☒ **Corroded**

CORRODED STEPS WITH EVIDENCE  
OF CORBEL INFILTRATION

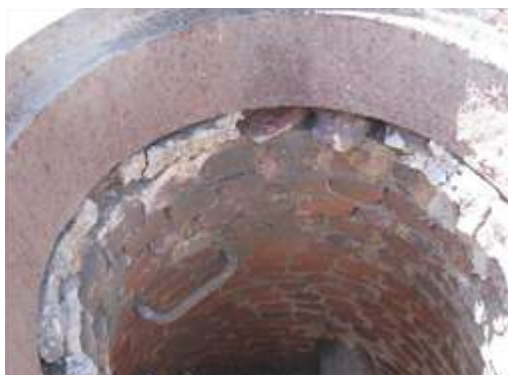
Defect 2

Condition: ☐ Sound ☐ Cracked ☐ Root Intrusion ☒ **Loose Brick** ☒ **Deteriorated**

Infiltration: ☐ None ☐ Joint ☐ Cracks ☒ **Mortar** ☐ Roots ☐ Wall

chimney loose bricks & deteriorated with  
signs of flow at mortar

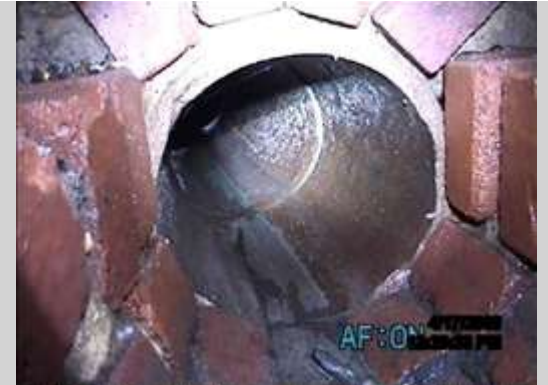
12 O'Clock Outflow

8 in. Circular Gravity Sewer  
Pipe Out @ 12 O'Clock

Pipe Height: **8.4** (in.) Rod and Bar (Angled)

Pipe Material: **Clay** ☐ Pipe Lined

Invert Depth: **6.51** (ft.) Flow Characteristics: **None**

Infiltration: **None** Pipe Seal Cond: **Sound**

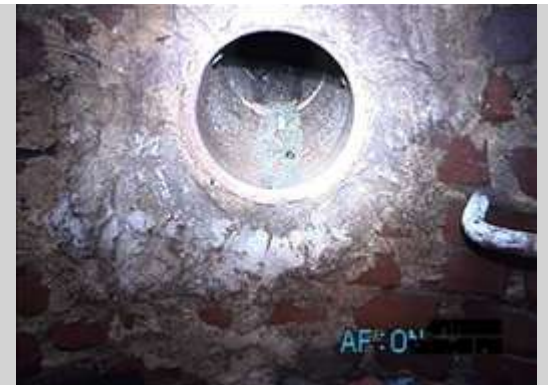
4 O'Clock Inflow

6 in. Circular Gravity Sewer  
Pipe In @ 4 O'Clock

Pipe Height: **6** (in.) Rod and Bar (Angled)

Pipe Material: **Clay** ☐ Pipe Lined

Invert Depth: **4.83** (ft.) Flow Characteristics: **None**

Infiltration: **None** Pipe Seal Cond: **Sound**

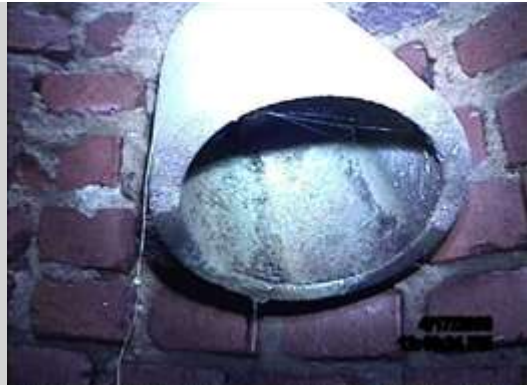
7 O'Clock Inflow

8 in. Circular Gravity Sewer

Pipe In @ 7 O'Clock

Pipe Material: **Clay** ☐ Pipe Lined

Invert Depth: **5.30** (ft.) Flow Characteristics: **None**

Connects To: **House connection / Service line**

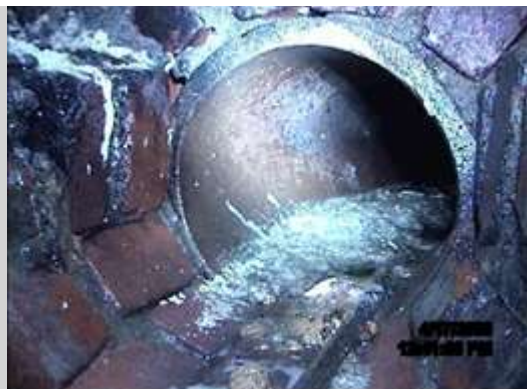
9 O'Clock Inflow

8 in. Circular Gravity Sewer

Pipe In @ 9 O'Clock

Pipe Height: **8.4** (in.) Rod and Bar (Angled)

Pipe Material: **Clay** ☐ Pipe Lined

Invert Depth: **6.70** (ft.) Flow Characteristics: **None**
